# Memorial Hall Condition Report

In 2025 the Town of Penhold commissioned a report of Memorial Hall's current condition in order to help assess the scope of work required to sustain Memorial Hall. The report showed several areas of concern that will require considerable expense to repair.

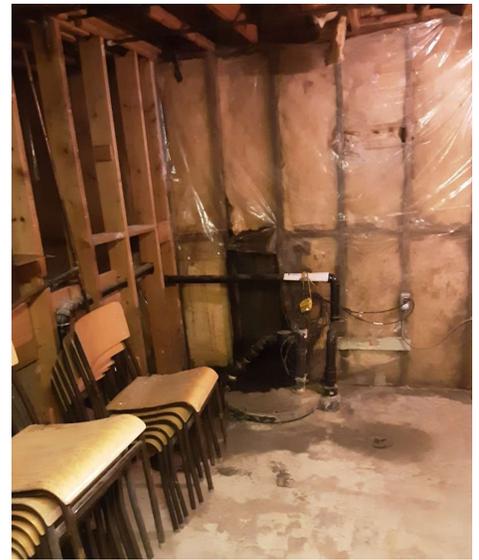
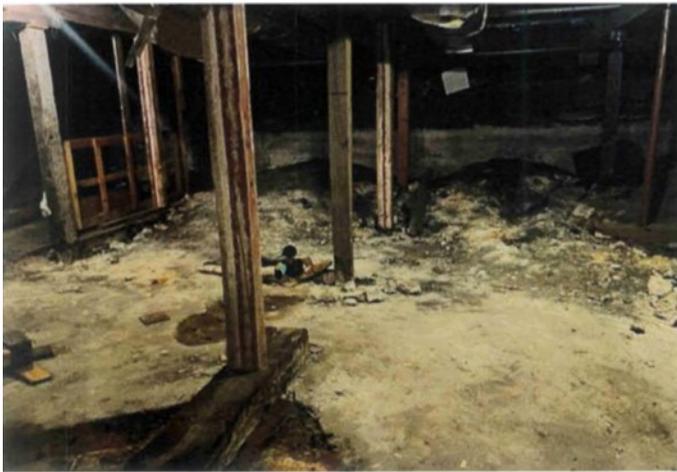
39 original 1919 Hall

The dirt basement of the original 1919 hall is also affected by moisture, including rot on the supporting posts and mold growth on the walls.

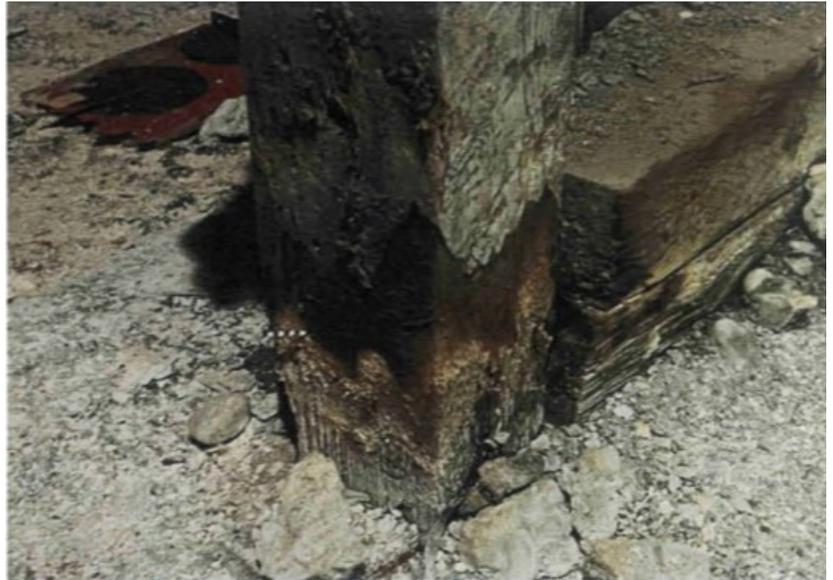
38 6x6 post rotten e bot. top

1. The 106-year-old 1919 original Memorial Hall has performed quite well and needs some extra care and attention to guarantee this old structure can serve the community for some more time. Most of the issues pertain to the undeveloped basement with dirt floor which has caused significant rot at the bottom of the supporting 6 x 6 wood posts. A little more investigation will be needed to check if any new footings are required before the exposed dirt surface is properly waterproofed with 10 mil poly and 3 inches of sand cover.

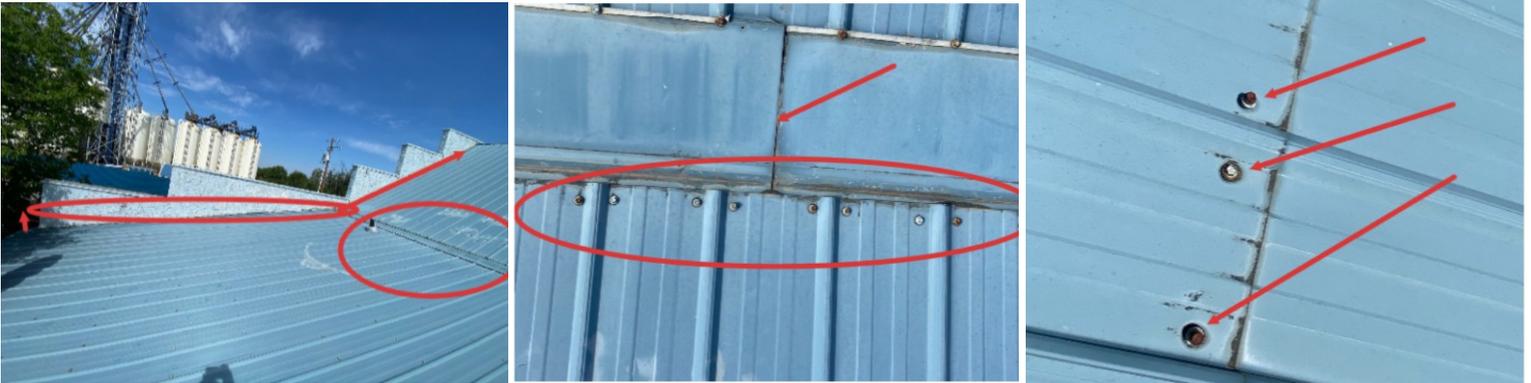
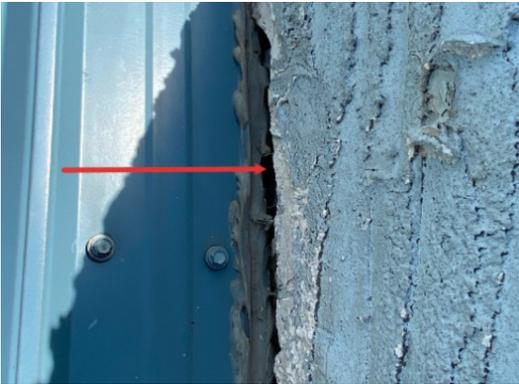
The roof covering the entire hall is also an area of concern. It has developed leaks in several different locations and will require replacement. The leaks have allowed water to enter the building and further exacerbated the moisture and mold problems.

The town of Penhold contacted Alberta's Best Roofing to assess the condition of the roof and an estimated cost of replacement. During the inspection several deficiencies were found, mostly related to lack of proper flashing, loose or missing fasteners, and incorrect use of materials.

The total estimate to replace the roof with asphalt shingles is: \$59,928.75 to \$66,822.00

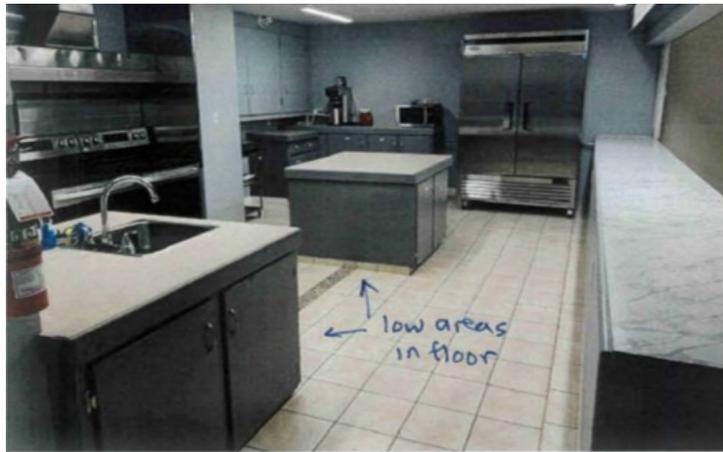
The condition of the structure of the building and the building envelope is also an area of concern. There is a very noticeable slope of the floor in the banquet room and kitchen in the 1977 addition.

35 Kitchen in 1972 Addn

7. Due to uneven floors in the banquet and kitchen areas, the supporting structure should be inspected and modified, if possible, to create a level floor surface.

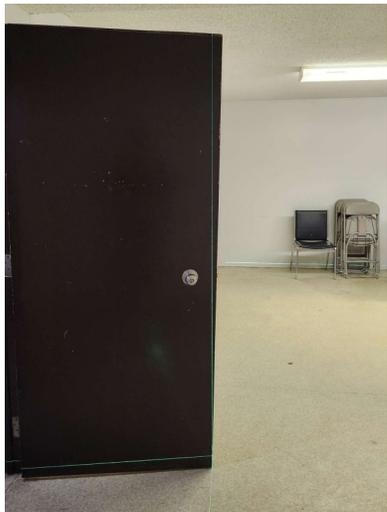
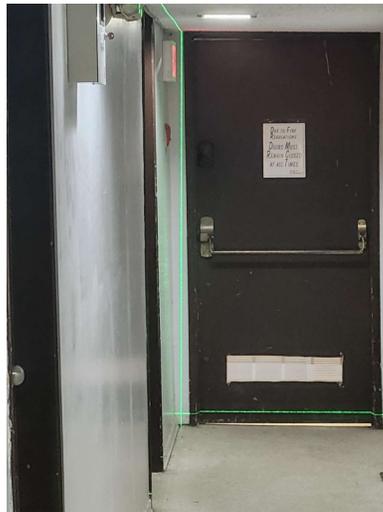
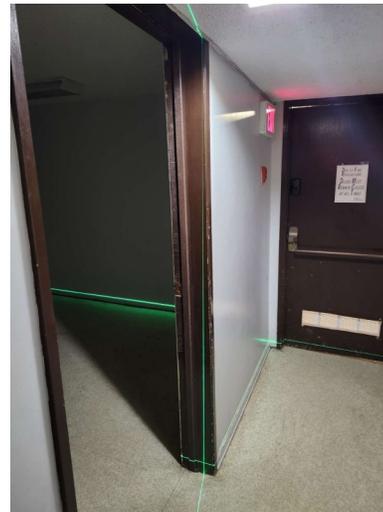
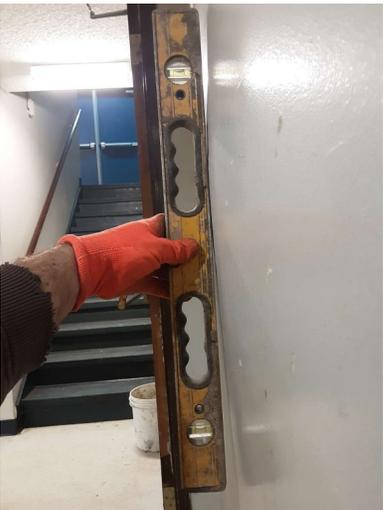
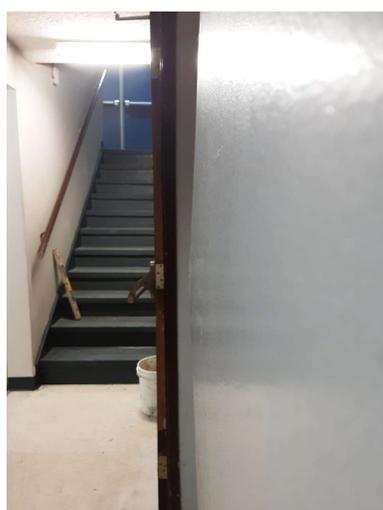
There is also an obvious lean in the basement hallway below and signs of foundation wall failure.

3. The connections at the top of the north end wall and the east side wall have partially failed, and it's probable that some PWF wood studs have also experienced structural failure. As a result, the basement walls should be opened to inspect the condition of the PWF stud walls.

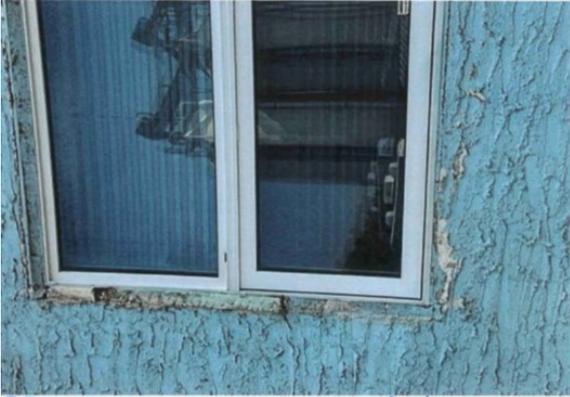
22 Rotten Window frame & no flashing

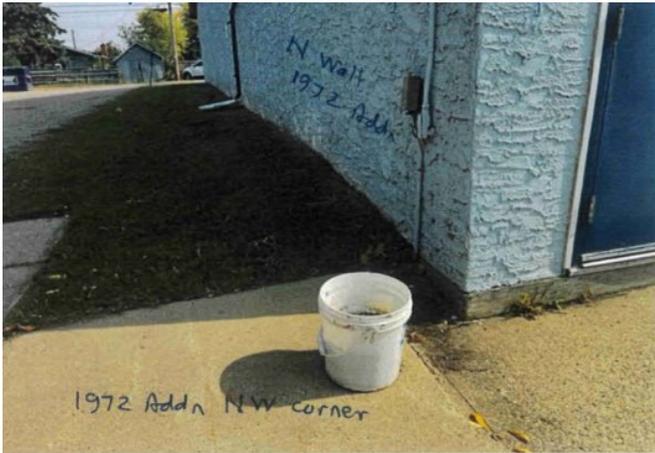
8 N wall, PWF end wall (bsmt wall) has failed & moved inwards due to high B/F

2. The 53-year-old 1972 N. Addition unfortunately is not in as good shape, mainly because the PWF basement has suffered high groundwater conditions along with excessive backfill pressure from higher adjacent grades & clay soils which have settled against these PWF walls and have caused surface water to run to the exterior of the PWF basement walls.
