# Memorial Hall Condition Report

In 2025 the Town of Penhold commissioned a report of Memorial Hall's current condition in order to help assess the scope of work required to sustain Memorial Hall. The report showed several areas of concern that will require considerable expense to repair.

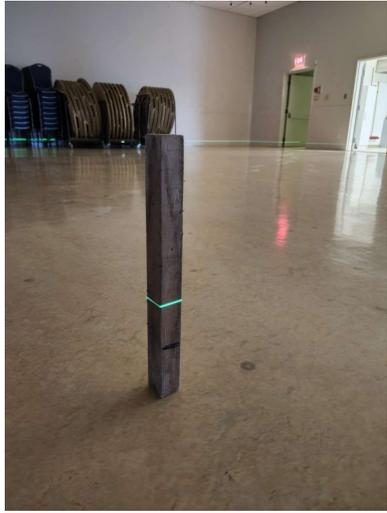
35 Kitchen in 1972 Addn

The condition of the structure of the building and the building envelope is also an area of concern. There is a very noticeable slope of the floor in the banquet room and kitchen in the 1977 addition.

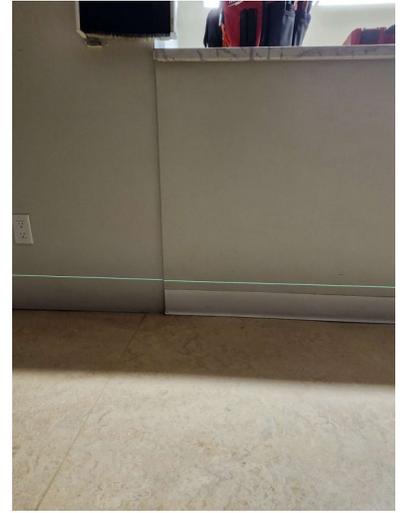
There is also an obvious lean in the basement hallway below and signs of foundation wall failure.

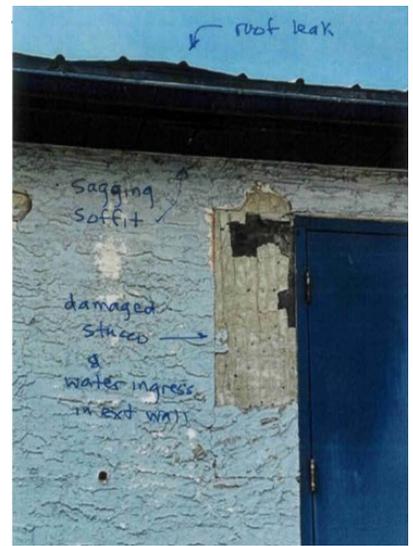
8 N wall, PWF end wall (bsmt wall) has failed & moved inwards due to high B/F

2. The 53-year-old 1972 N. Addition unfortunately is not in as good shape, mainly because the PWF basement has suffered high groundwater conditions along with excessive backfill pressure from higher adjacent grades & clay soils which have settled against these PWF walls and have caused surface water to run to the exterior of the PWF basement walls.

3. The connections at the top of the north end wall and the east side wall have partially failed, and it's probable that some PWF wood studs have also experienced structural failure. As a result, the basement walls should be opened to inspect the condition of the PWF stud walls.

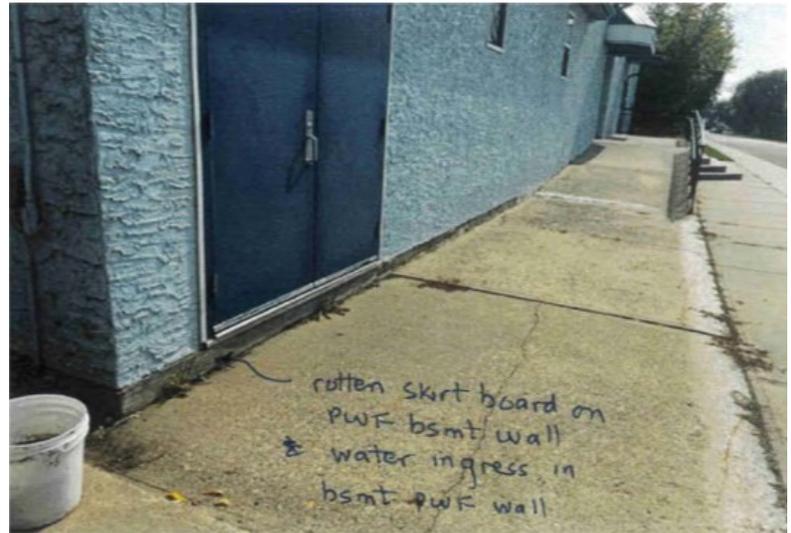
The building envelope is also in need of repair. Most notably, stucco has failed in various areas around the building, allowing moisture to penetrate the walls and foundation.

5. Some sections of the building's stucco exterior are deteriorated and damaged, with significant rusting present on the underlying metal mesh. Replacing the stucco is advised, particularly on the east and north walls and near the east exit door below the section where the roof is leaking.
